Manhole Inspection Summary

Manhole # S21CC2001MH

Insp Date: **11/20/06 1:25 PM**

Location Address: **5523 MATTFELDT AVE**

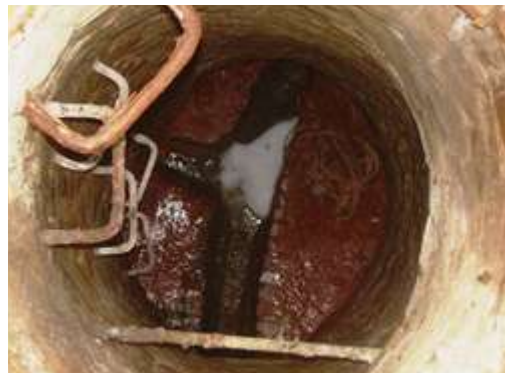
Top View

☐ Parged ☒ **Debris** (not Condition related)

Count: **8** Missing: **0** ☒ **Corroded**

Corroded steps. Bench debris.

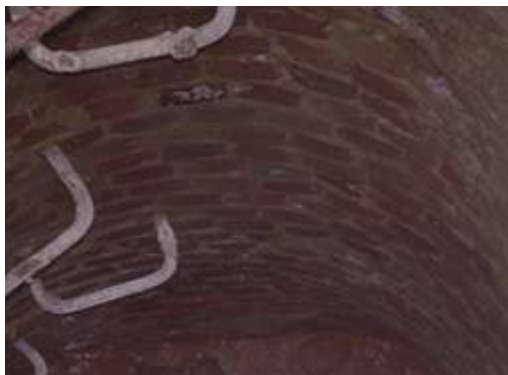
Defect

Infiltration: ☐ None ☐ Joint ☐ Cracks ☒ **Mortar** ☐ Roots ☒ **Wall**

Barrel infiltration.

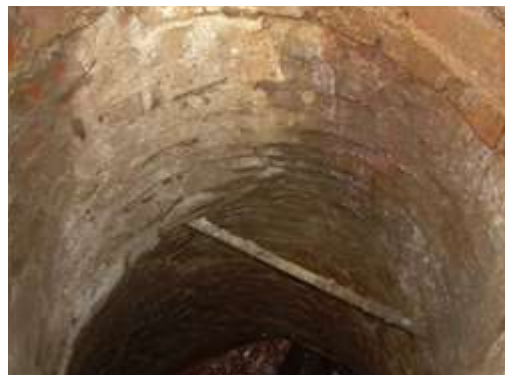
Defect

Condition: ☐ Sound ☐ Cracked ☐ Root Intrusion ☐ Loose Brick ☒ **Deteriorated**

Infiltration: ☐ None ☒ **Joint** ☐ Cracks ☒ **Mortar** ☐ Roots ☐ Wall

Adjustment deterioration and infiltration.
Barrel infiltration.

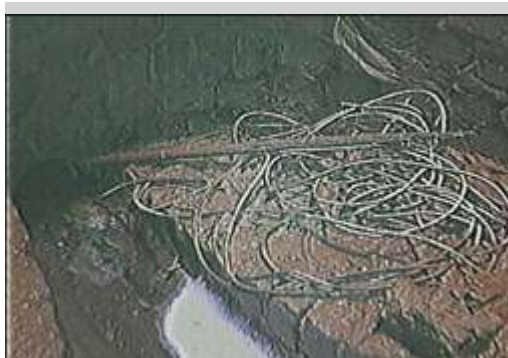
Defect

Condition: ☐ Sound ☐ Cracked ☐ Root Intrusion ☐ Loose Brick ☒ **Deteriorated**

Condition: ☐ Sound ☐ Cracked ☐ Root Intrusion ☒ **Deteriorated** ☐ Leaks ☐ Debris

Condition: ☐ Sound ☐ Cracked ☐ Root Intrusion ☒ **Deteriorated** ☐ Leaks ☒ **Debris**

Barrel deterioration and infiltration. Bench
and Channel deterioration.

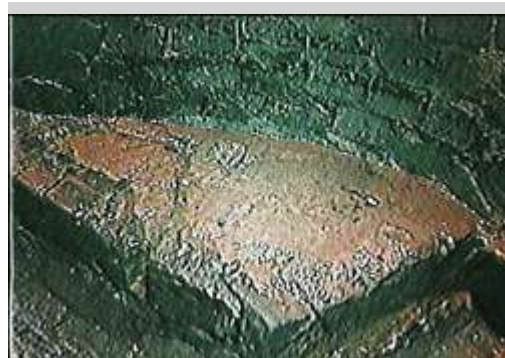
Defect

Barrel deterioration and infiltration. Bench
and Channel deterioration.

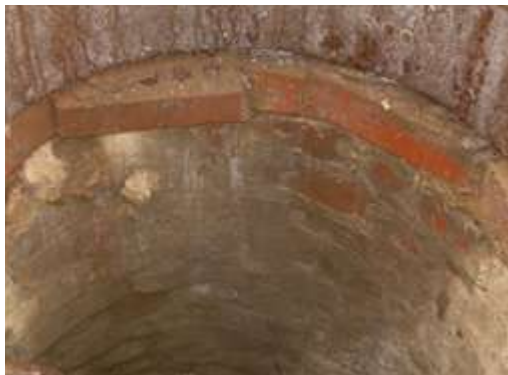
Defect

Adjustment deterioration and infiltration.

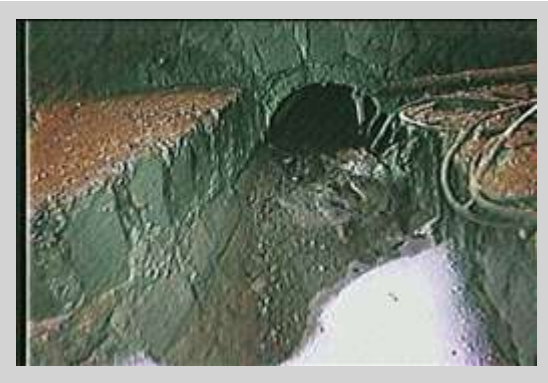
8 in. Circular Gravity Sewer Pipe Out @ 12 O'Clock

Pipe debris.

Deposits: ☐ None ☒ **Mud** ☐ Sludge ☒ **Debris** ☐ Grease

Silt Depth: **2** (in.) Deposits Extent: **Medium**

Infiltration: **Evidence** Pipe Seal Cond: **Unknown**

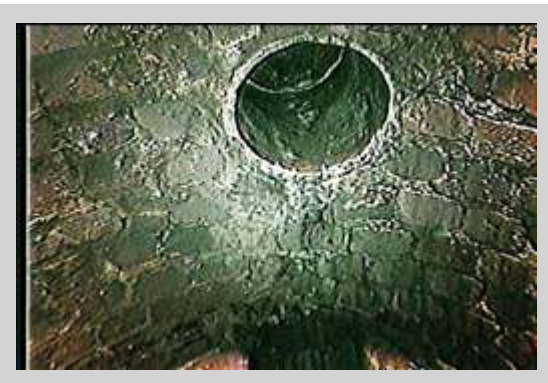
8 in. Circular Gravity Sewer Pipe In @ 5 O'Clock

Infiltration: **Evidence** Pipe Seal Cond: **Unknown**

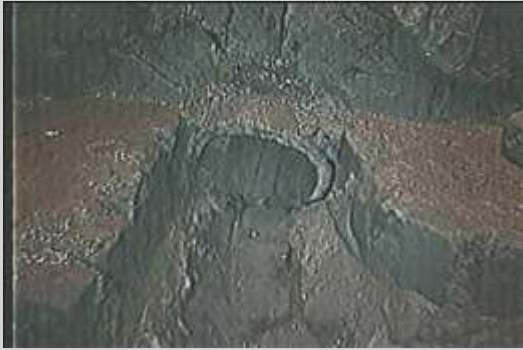
Pipe In @ 9 O'Clock

Barrel deterioration and infiltration. Bench and Channel deterioration.

Infiltration: **Weeper** Pipe Seal Cond: **Unknown**
